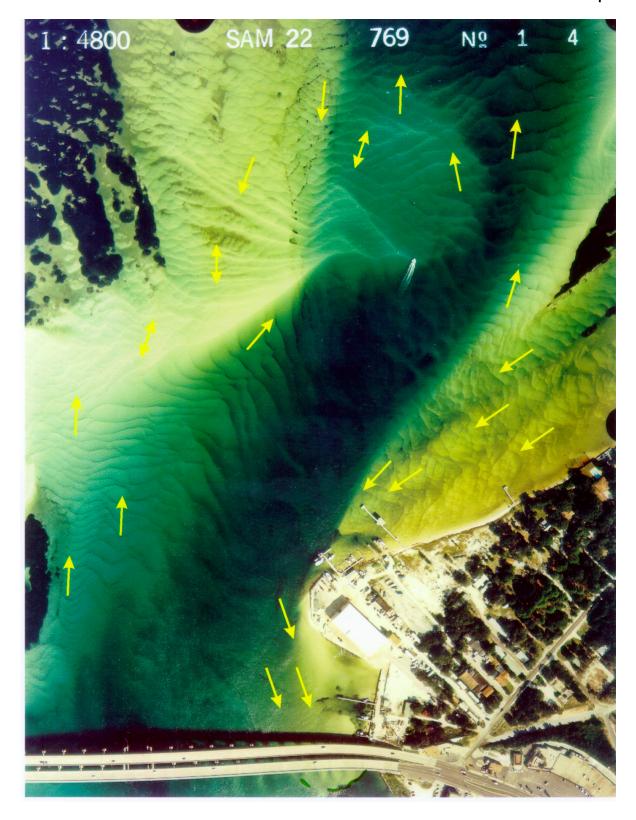
Figure IV-3-5. Flood shoal, East Pass, Florida (23 Sep 1987). North is to the top. The Gulf of Mexico is about 1 km south of the Hwy 98 bridge at the bottom of the image. Dunes in the main channel are flood-oriented (toward the top of the image), while bed forms in the marginal channels are ebb-oriented (Photograph courtesy of USAED, Mobile)
